**CALSPAN ON-SITE AIR BAG DEPLOYMENT
FOREARM FRACTURE CRASH INVESTIGATION**

CALSPAN CASE NO. CA 96-05

**VEHICLE #1 - 1995 VOLVO 940
VEHICLE #2 - 1994 NISSAN SENTRA XE LIMITED EDITION**

LOCATION - STATE OF NEW YORK

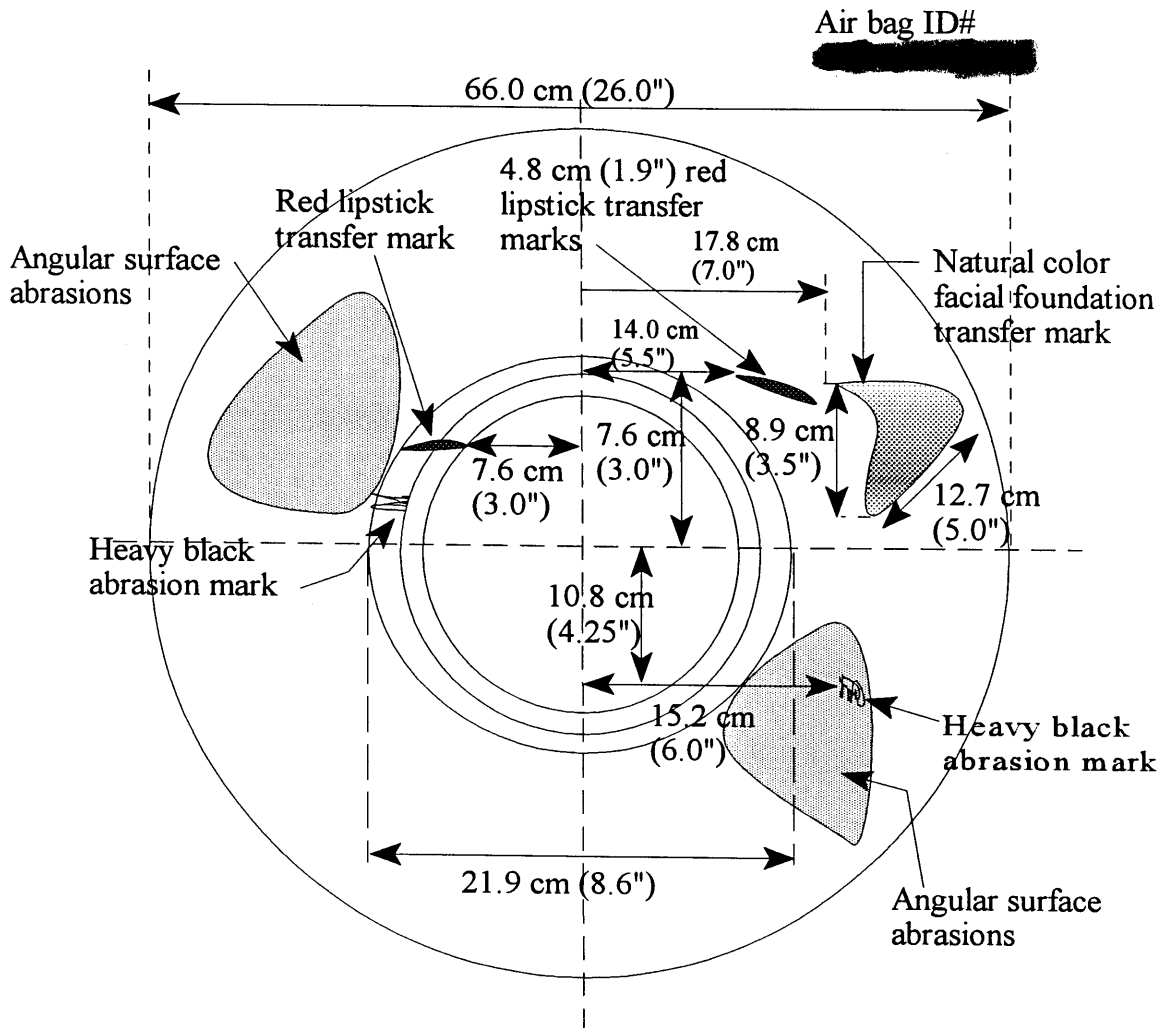
Vehicle #1- Contact Evidence on Driver Side Tethered Air Bag

During the air bag deployment sequence, the expanding driver side air bag contacted her arm and propelled it to the right. Simultaneous with this interaction, the driver's facial area was in close proximity of the expanding air bag which resulted in a scattered cosmetic transfer pattern on the air bag. Red lipstick and natural color facial foundation cosmetic transfers noted in the right side of the

air bag were separated from red cosmetic transfers in the upper quadrant of the air bag by a distance of 21.6 cm (8.5") quadrant. This pattern indicated the driver's facial area was in contact with the air bag while the air bag was undergoing the unfolding and expansion process. The driver sustained abrasions of the chin, nose, right lip area, and undersurface of the neck which were attributed to the air bag contact.

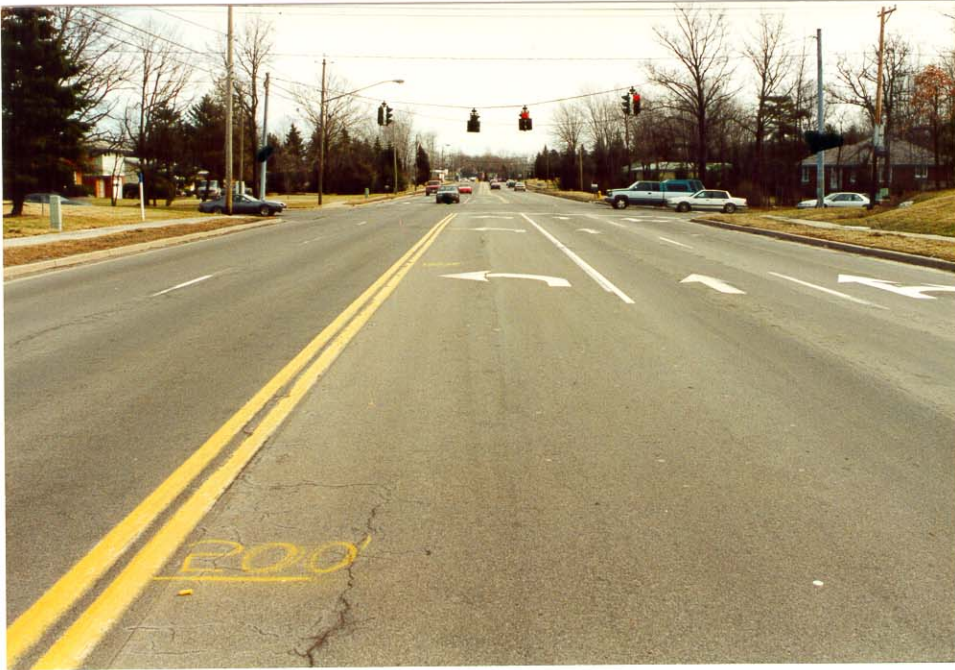
1. View of the eastbound pre-crash trajectory of the 1995 Volvo 940 (Vehicle #1) at 61 meters (200 ft.) prior to the point of impact (POI).

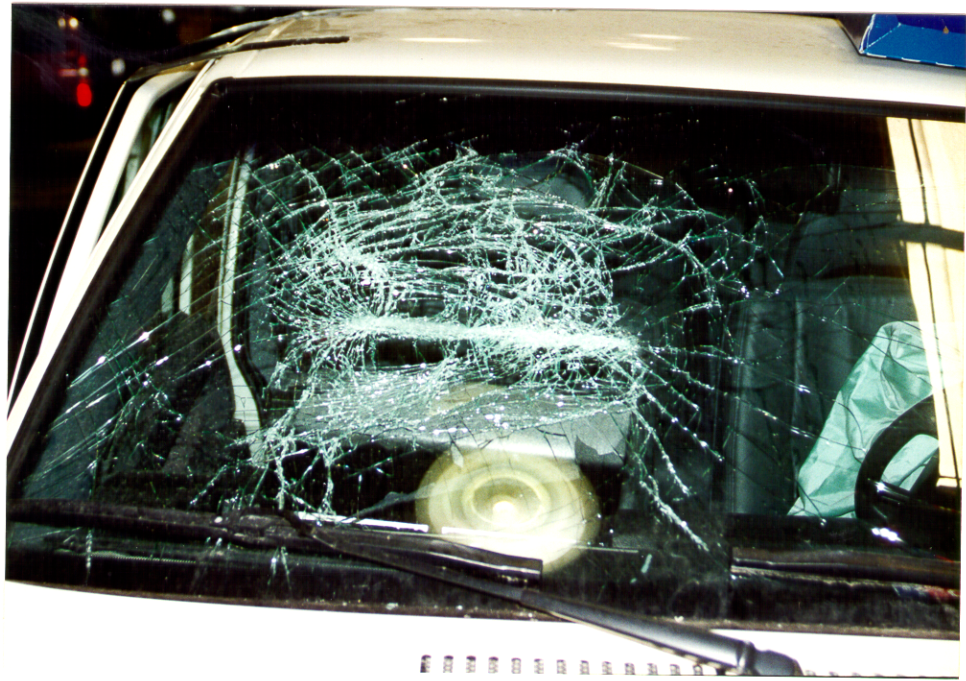
The windshield glazing exhibited a fracture pattern which was consistent with contact by the passenger side air bag module flap during the SRS deployment sequence. It measure 25.4 cm (10.0") laterally and was located 19.1 cm (7.5") right of the vehicle centerline and 19.1 cm (7.5") above the instrument panel. The rearview mirror was rotated in a clockwise direction.

15. View of the right side of the windshield fractured by the passenger side air bag module cover.

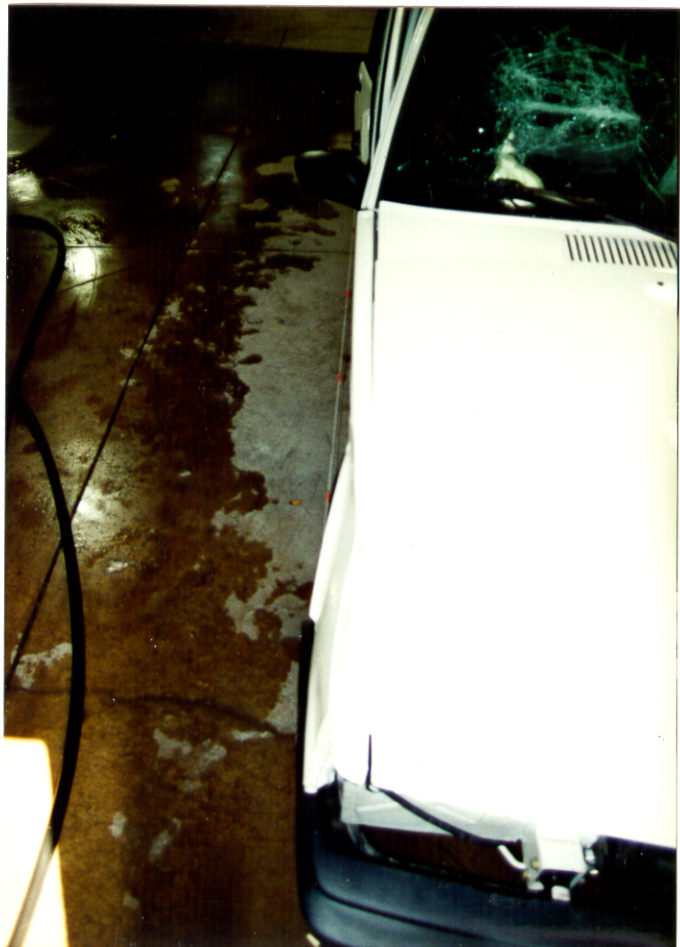
16. Longitudinal view of the right side plane.

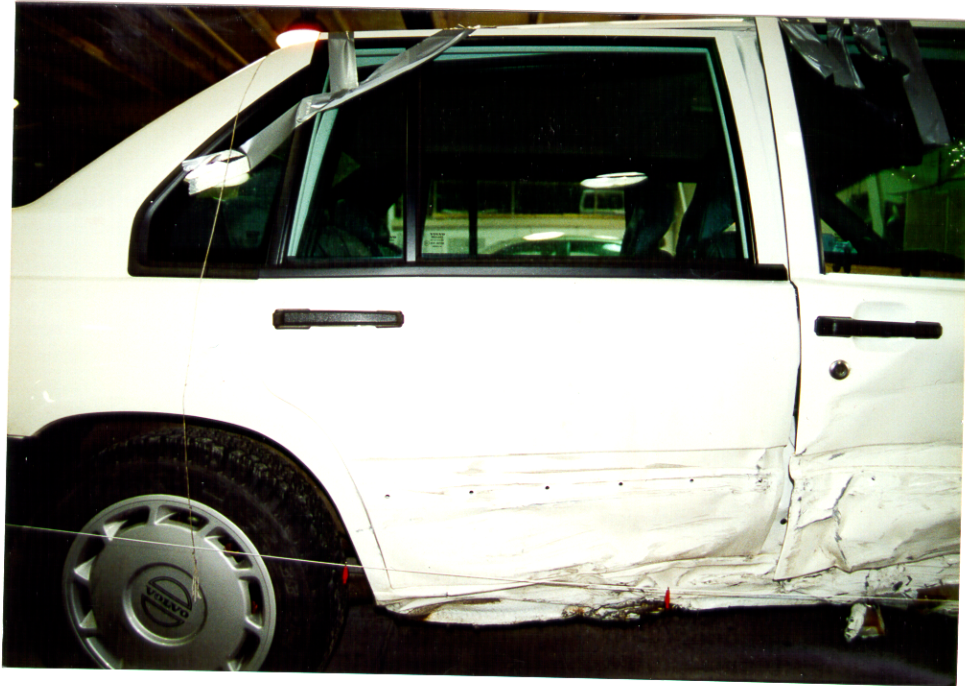
23. Close-up view of the damage to the right rear door.

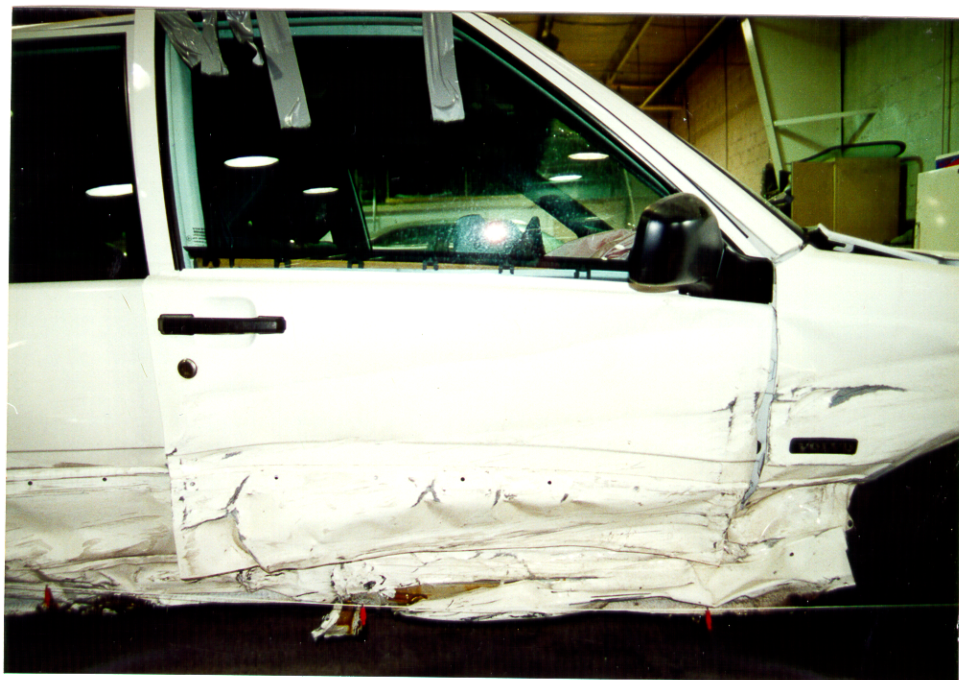
24. Close-up view of the damage to the right front door panel.

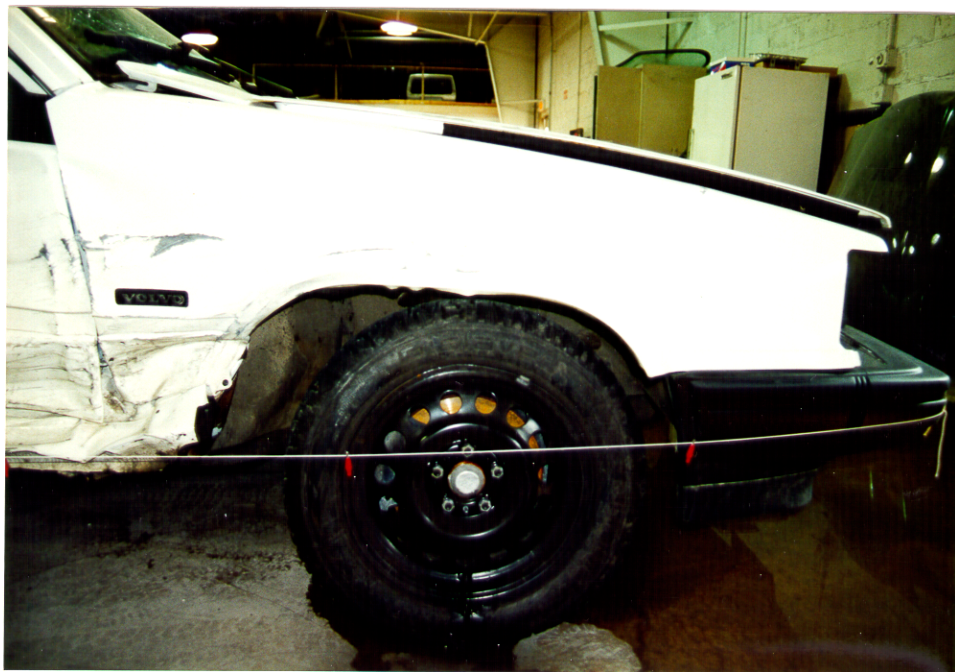
25. View of the damage to the right front fender.

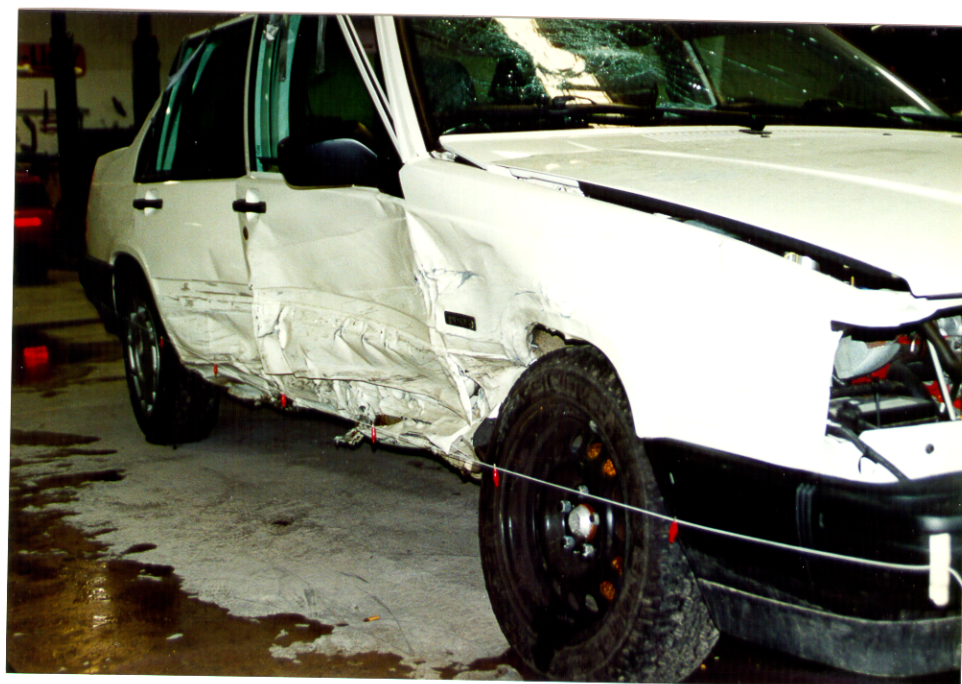
26. Angular view of the damage to the right side of Vehicle #1.

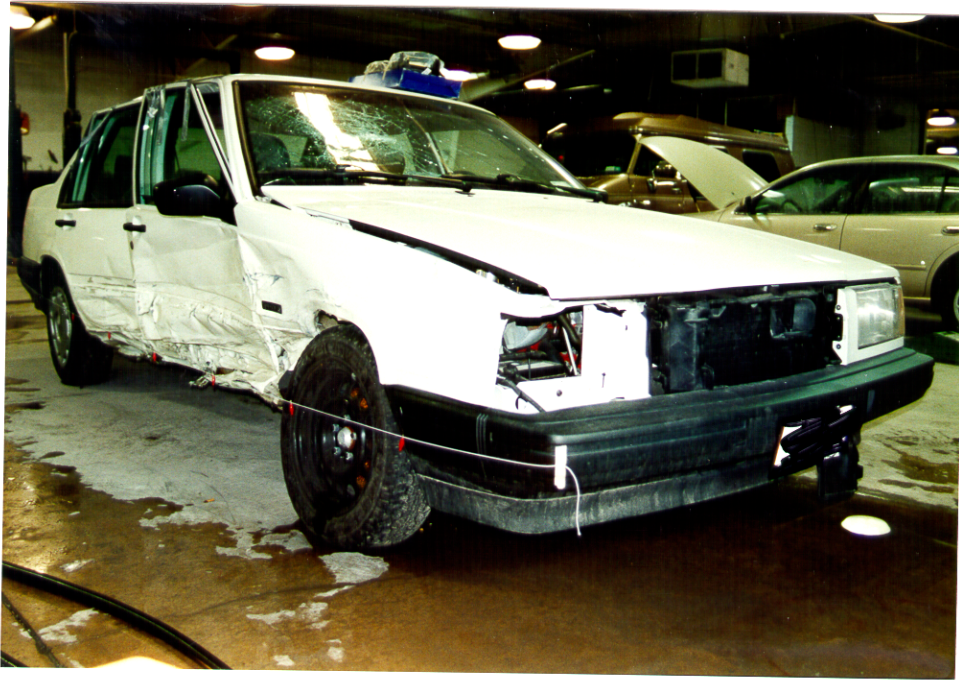
27. Right front corner view.

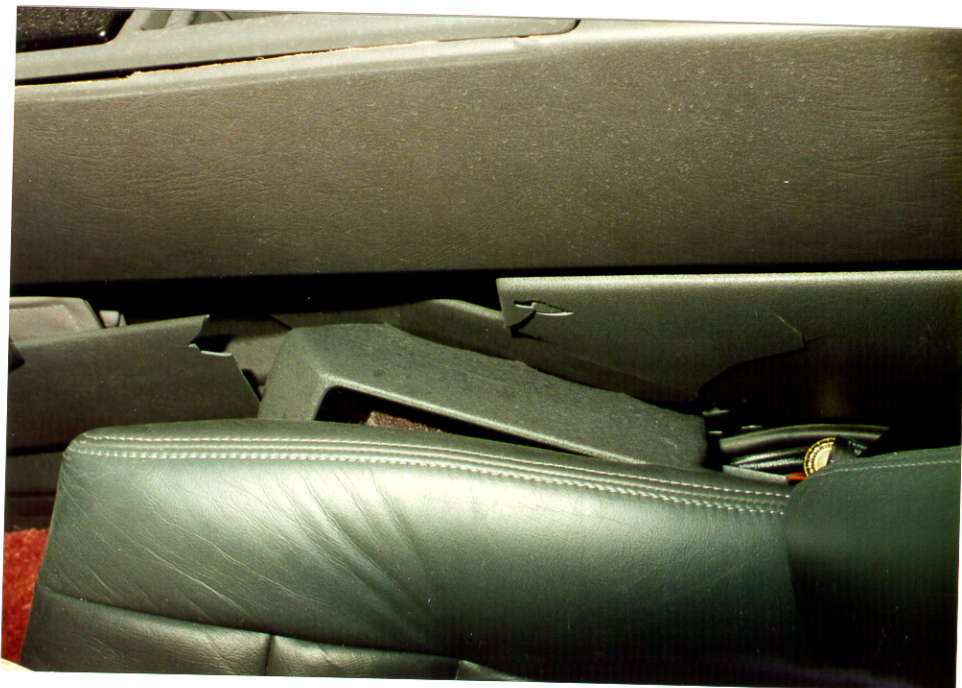
30. Close-up view of the right front door intrusion.

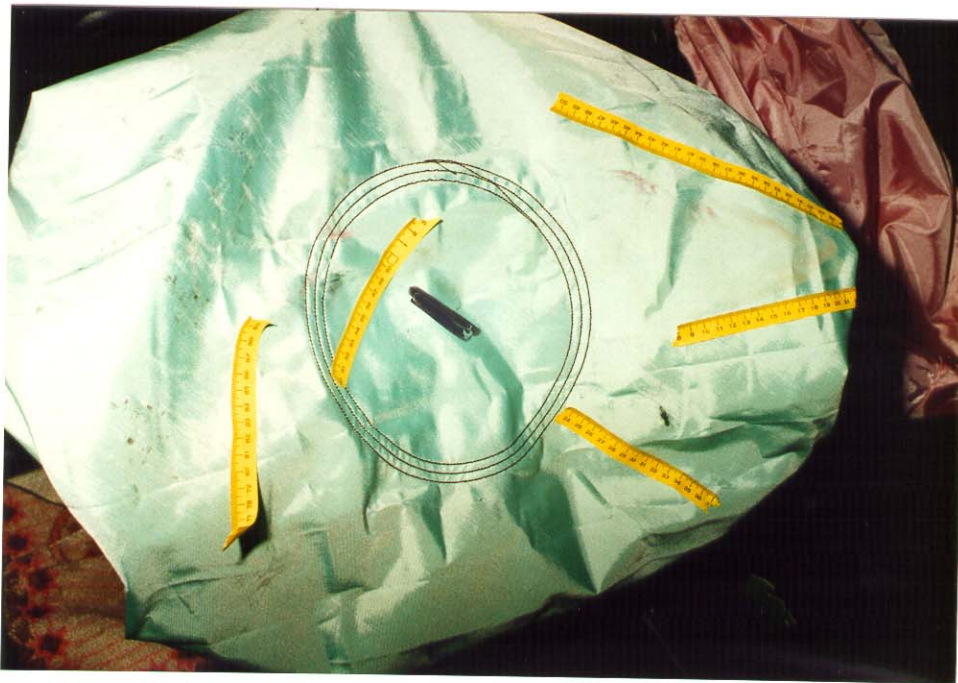
Interior damage to the 1995 Volvo 940 was associated with the air bag deployment, contact by the driver, and intrusion from the impact with Vehicle #2. The driver side air bag module cover opened along the designed tear seam lines in the typical "H" configuration deployment pattern. A scuff mark measuring 2.5 cm (1.0") laterally and 3.8 cm (1.5") vertically was noted on the air bag module cover (refer to photographs #31, #33 on pages A-16, A-17). This was attributed to contact by the driver's right forearm during the air bag deployment sequence. Red lip stick and natural color facial foundation cosmetic transfers were noted on the driver side air bag located along the right side and upper left quadrant of the air bag which were attributed to contact by the driver's facial area (refer to photograph #38 on page A-19).

38. View of transfer evidence on the driver side air bag.

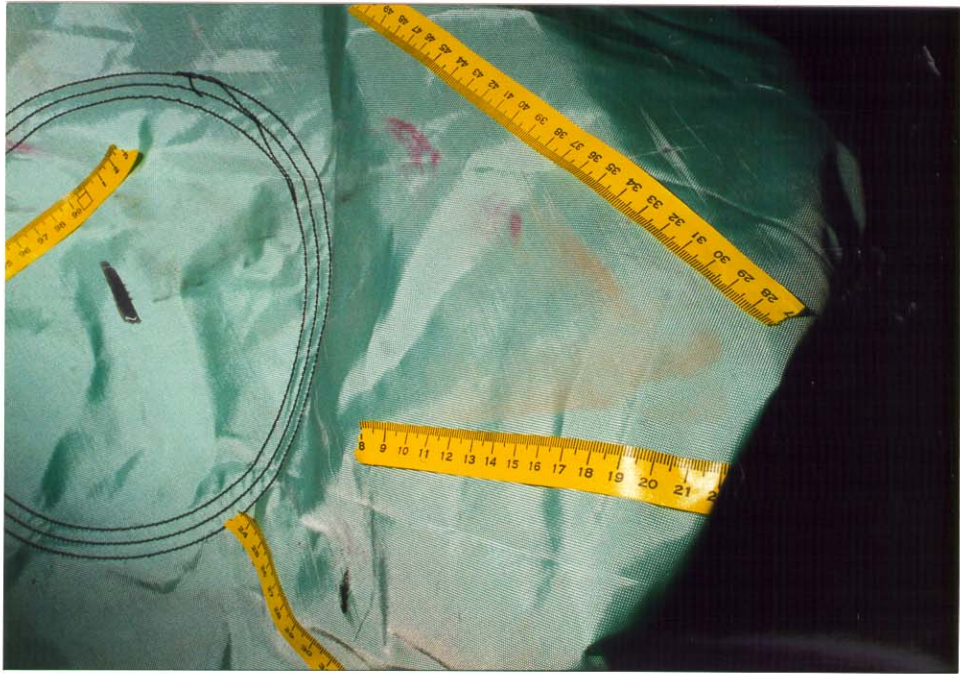
39. Close-up view of a large triangular natural color foundation cosmetic transfer mark on the 3 o'clock sector of the bag.

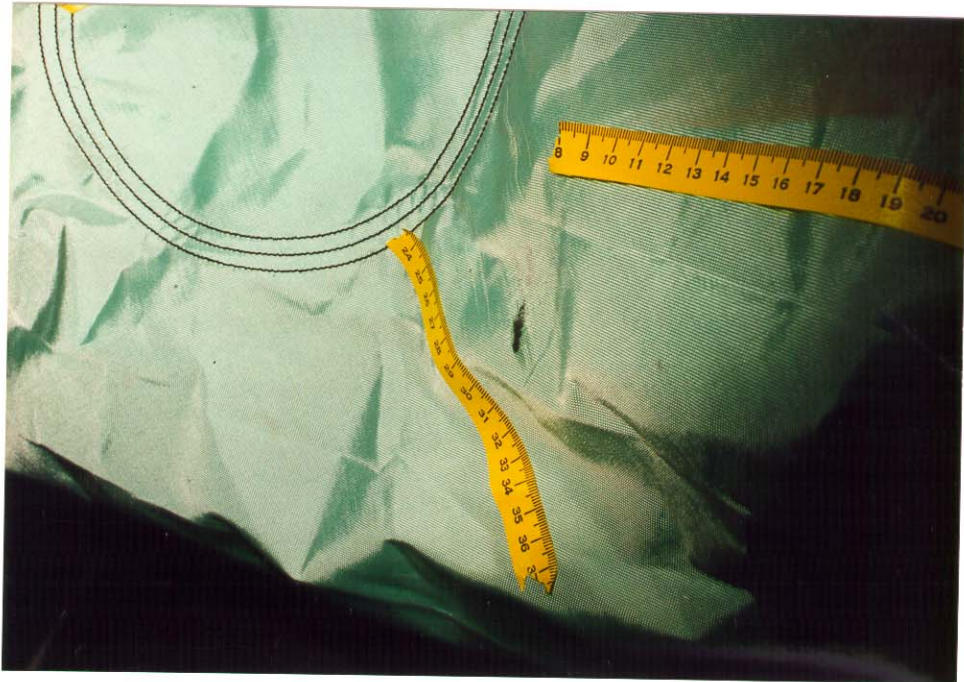
40. Heavily abraded area and a black transfer mark located on the lower right quadrant of the driver side air bag.

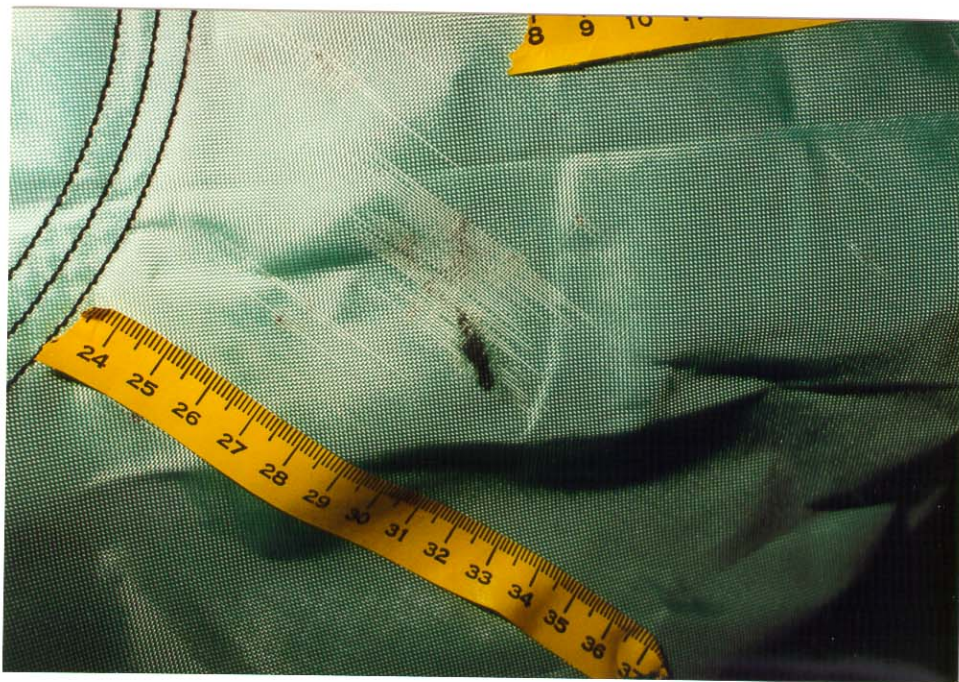
41. Close-up view of the abraded area and black transfer mark.

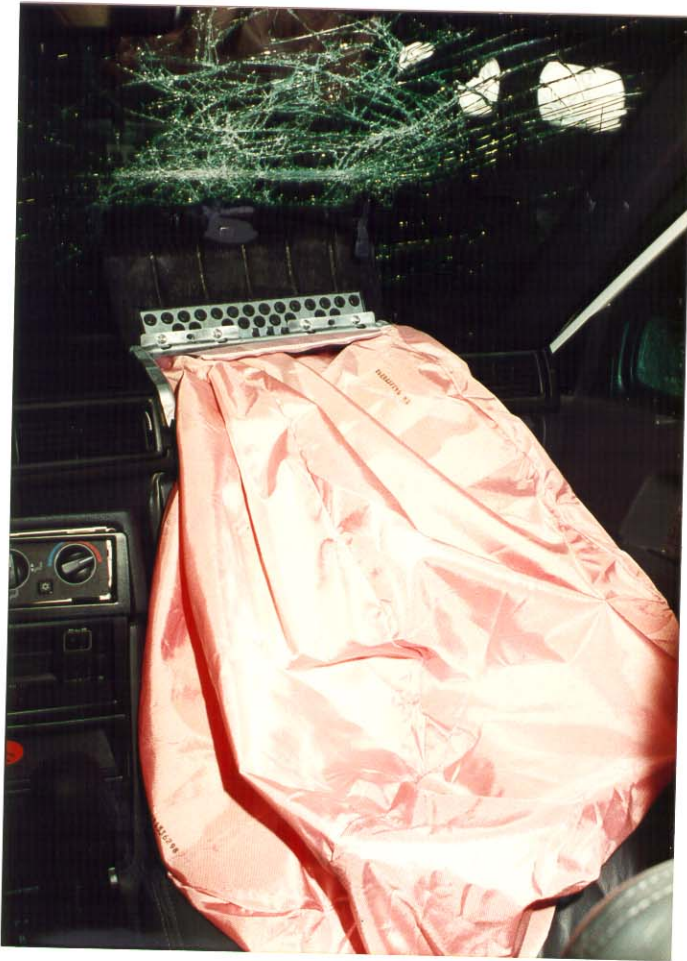
47. Vertical view of the passenger side air bag in an extended position, air bag module cover, instrument panel, and windshield.

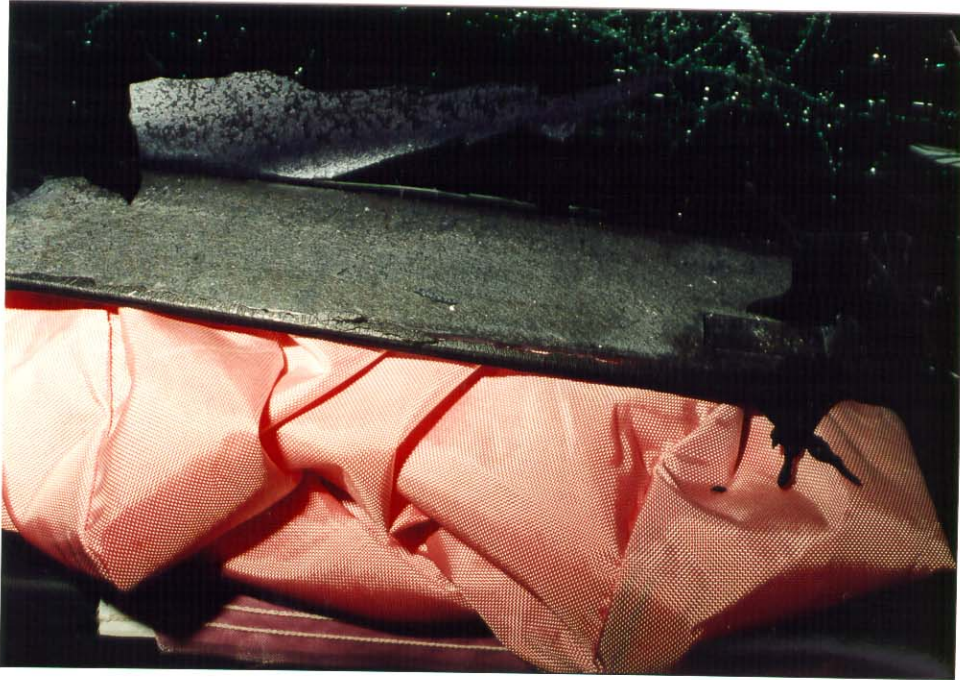
49. View of the top of the air bag module cover flap.

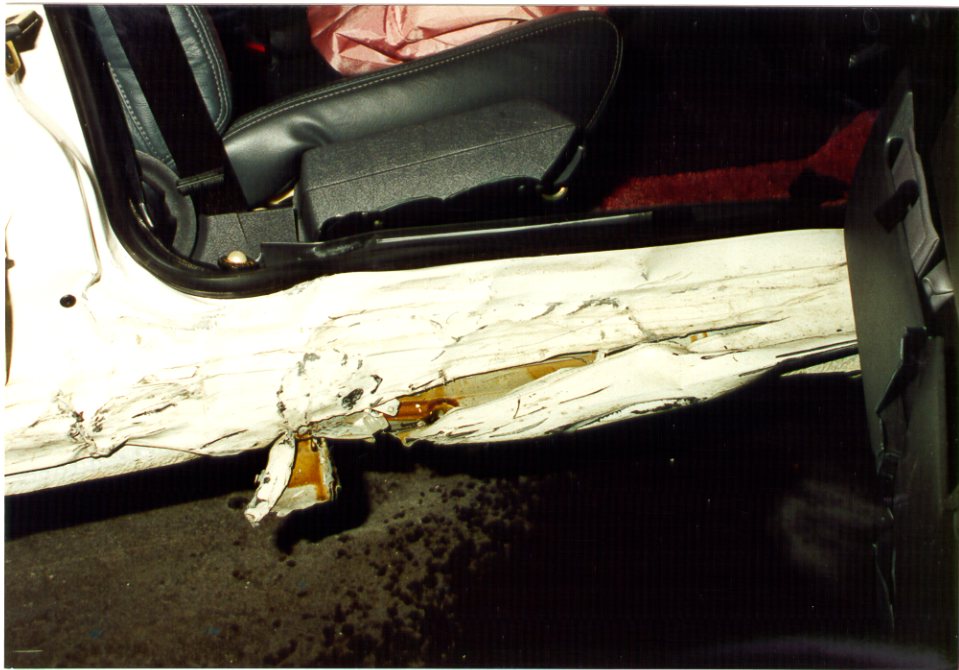
51. Intrusion damage on the lower right front door area.

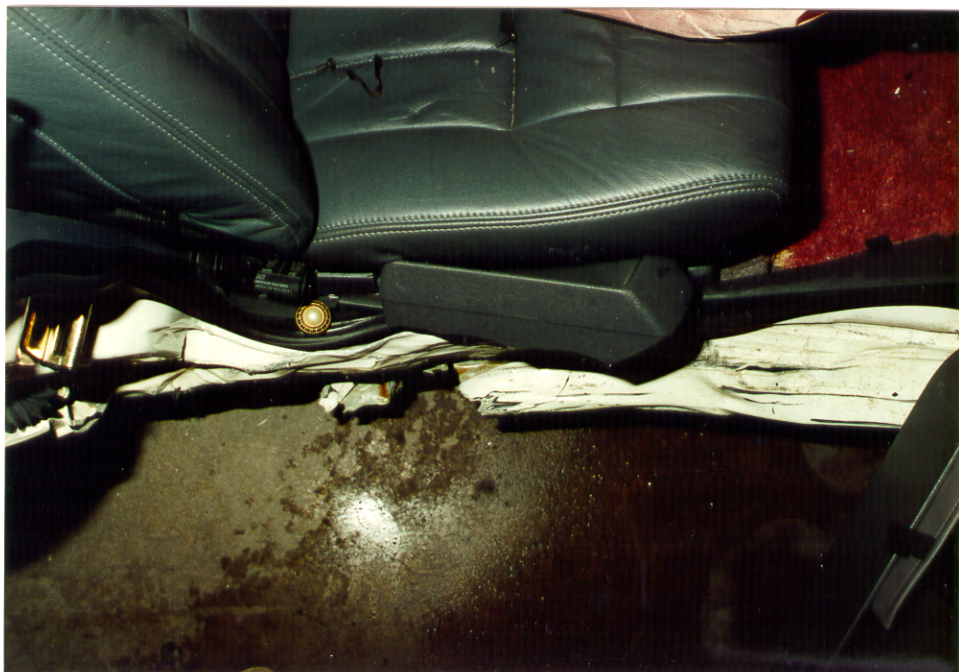
52. Overhead view of the extent of intrusion damage.

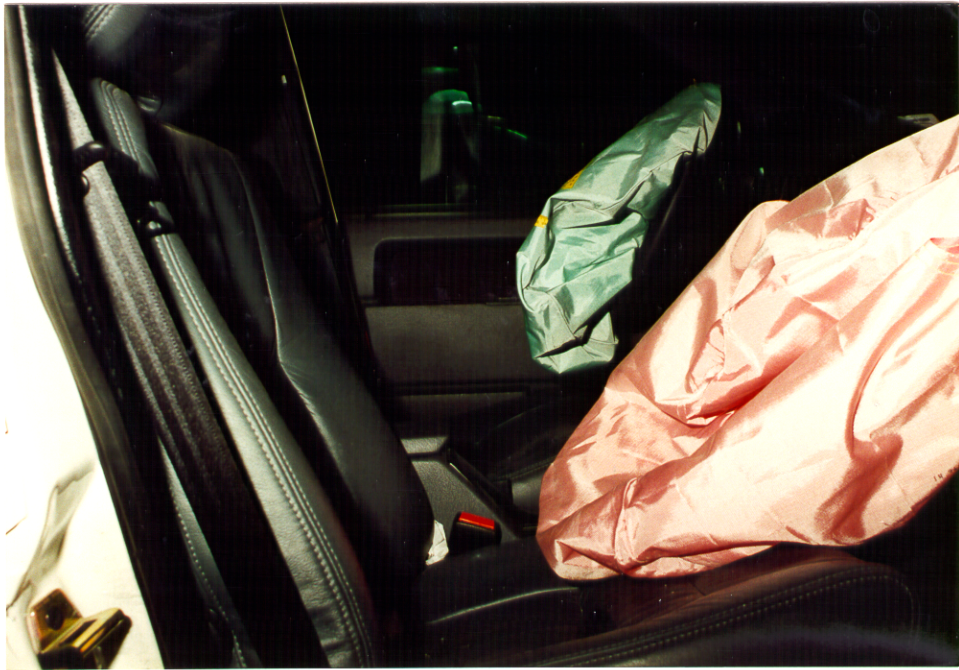
53. Lateral view from the right side showing the excursion of the passenger side air bag into the right front seat area.

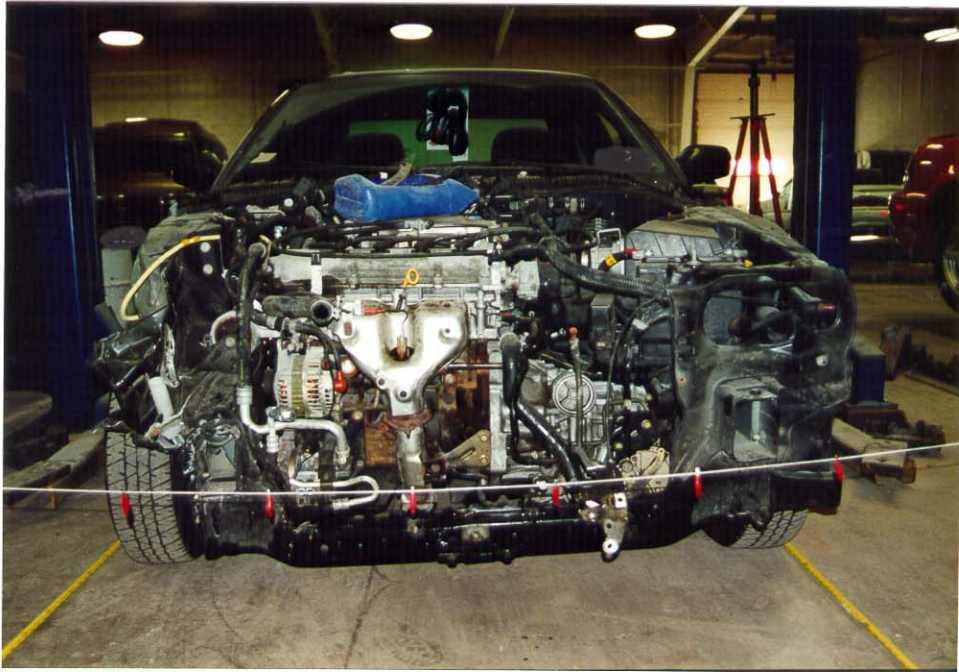
69. Overall frontal view of the 1994 Nissan Sentra (Vehicle #2) with the front of the vehicle removed (vehicle under repair at time of inspection).

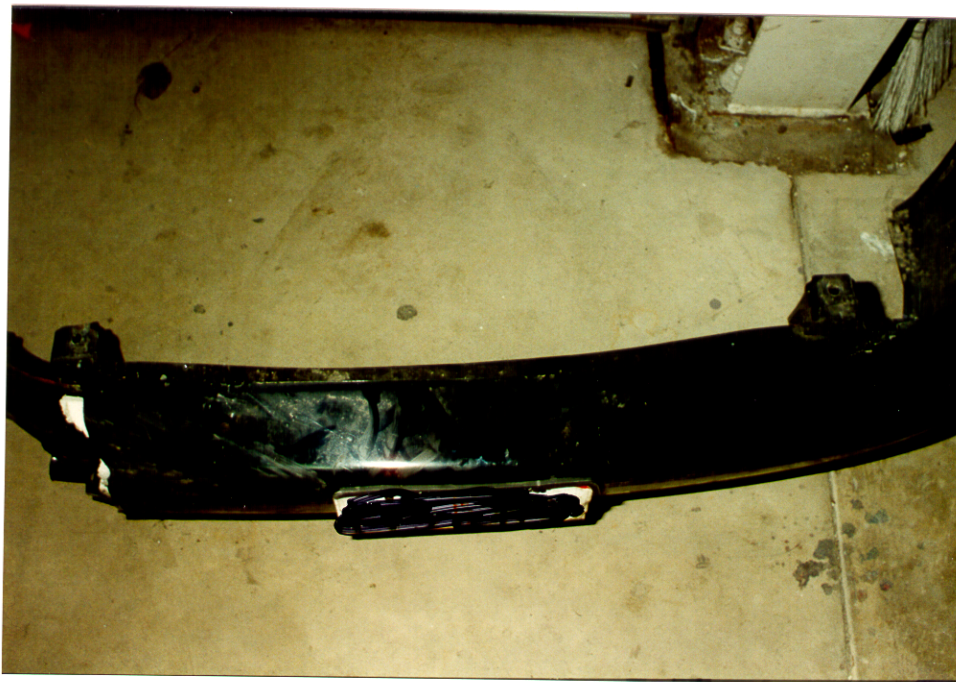
The right frontal plane of the Vehicle #2 contacted the right side plane of Vehicle #1. Direct contact along the bumper measured 52.1 cm (20.5") and was located 12.7 cm (5.0") right of the vehicle centerline (refer to photographs #72-#74 on pages A-36, A-37). The total length of direct and induced damage measured 105.4 cm (41.5"). The vehicle was dismantled at the time of inspection, however, crush values were derived using the displacement of the frame rails with respect to the overall longitudinal reference line. These values were subsequently adjusted for free space using the contour of the front bumper which resulted in the following C dimensions:

72. Overhead view of the front bumper.

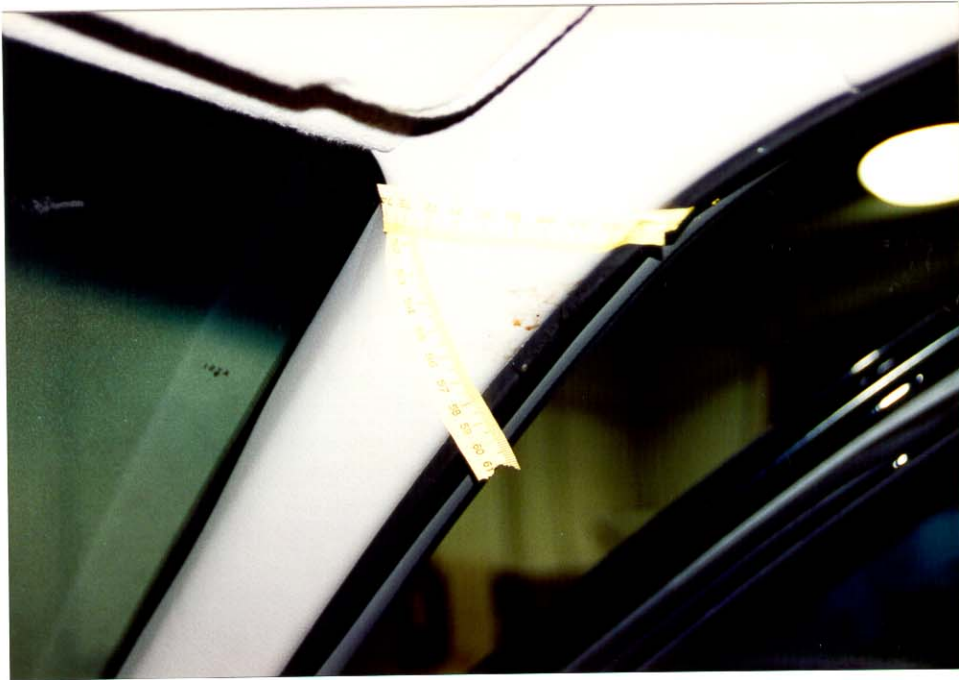
A fluid spray was noted to the upper right A-pillar. This may have been deposited during the crash sequence from an open soda container as the general condition of the interior appeared clean.

93. Liquid residue (possible soda spray) on the upper A-pillar.

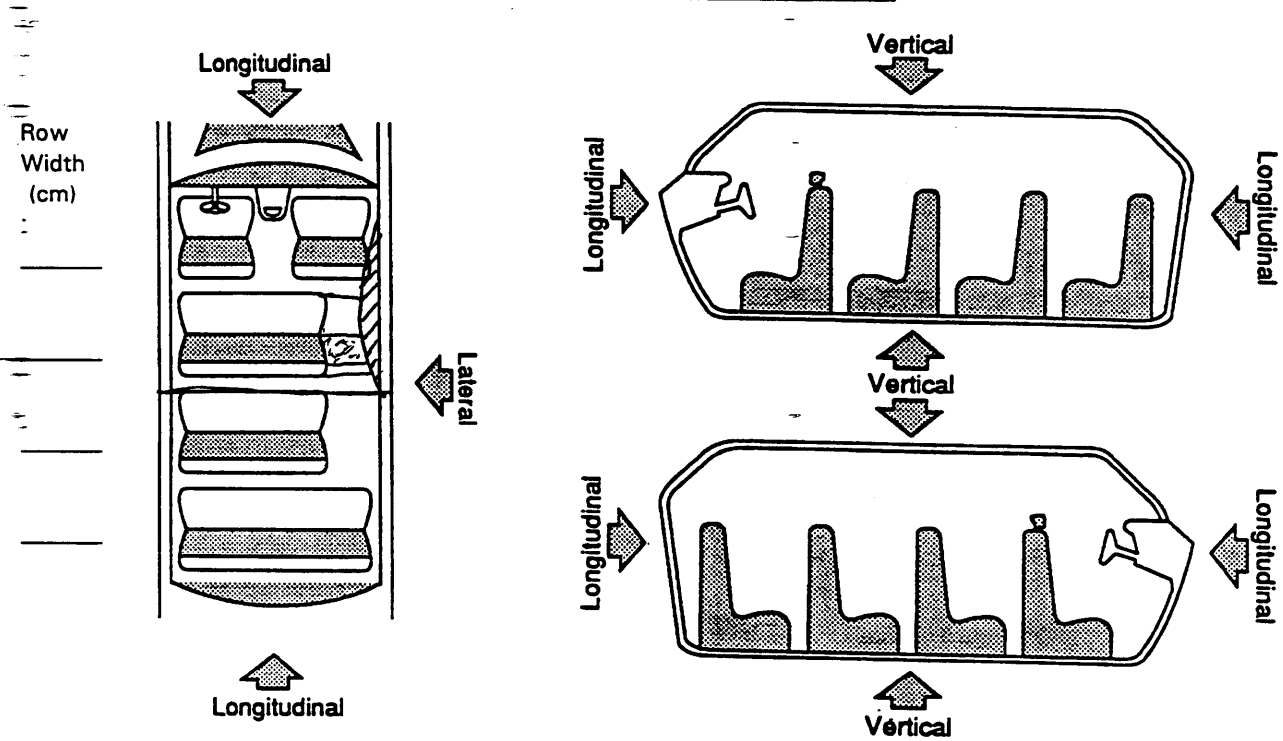
INTRUSION WORKSHEET

LOCATION OF INTRUSION	INTRUDED COMPONENT	(All Measurements Are In Centimeters)			DOMINANT CRUSH DIRECTION
		COMPARISON VALUE	INTRUDED VALUE	INTRUSION	
13	Side	64.8 cm	57.2 cm	7.6 cm	Lat
13	Door	67.3 cm	57.2 cm	10.1 cm	Lat
13	Seat	59.7 cm	55.9 cm	3.8 cm	Lat
23	Door	69.9 cm	59.7 cm	10.2 cm	Lat
23	Side	69.9 cm	58.4 cm	11.5 cm	Lat
13	B-pillar	67.3 cm	59.7 cm	7.6 cm	Lat
		-		=	
		-		=	
		-		=	
		-		=	
		-		=	
		-		=	
		-		=	
		-		=	
		-		=	
		-		=
